Stormwater System Repair

Project Name: Propex
Method Used: CIPP Lining with Tunnel Liner Plates
Original Pipe Material: Corrugated Metal Pipe

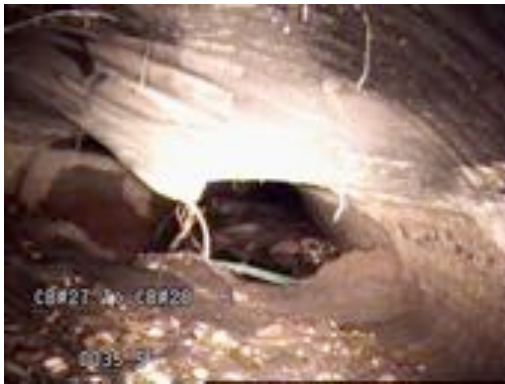
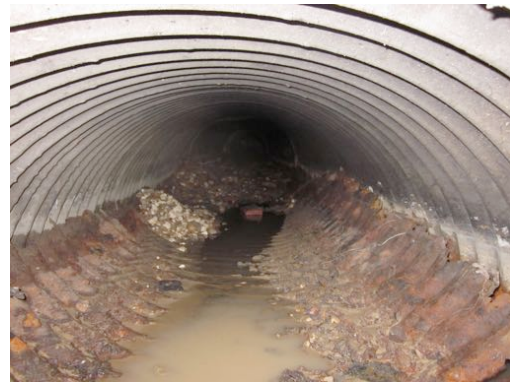
Collapsed Lines Inside the Plant

Thirty-five sections outside the plant and twenty-two sections inside the plant were inspected. Inspections revealed corrugated metal pipe full of debris, some partially collapsed, and some completely collapsed.

Of the three collapsed lines, 2 were outside the building and 1 inside. Catch basins were covered inside the building, and the pipes deformed. Inspections continued, but the collapsed lines became the priority. Propex decided to repair the outside collapses, while SPS began formulating a strategy to deal with the problem on the inside of the building.

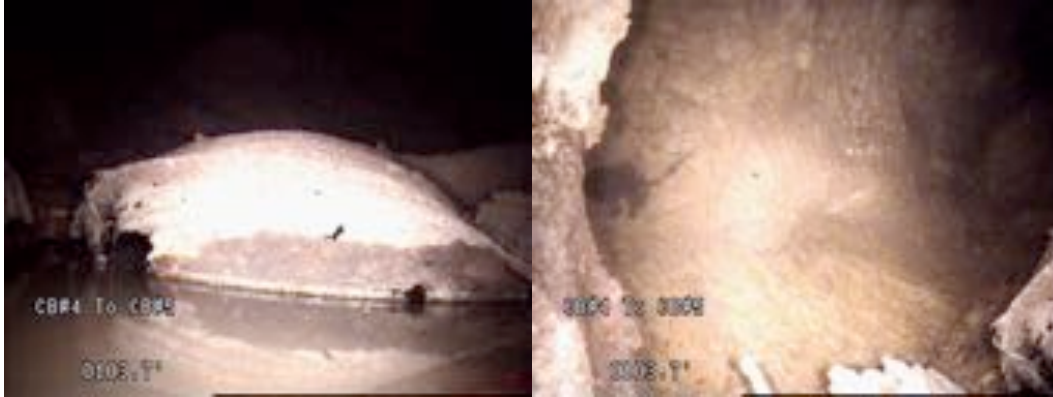
Along with the collapse, there was a 10' to 15' void underneath the floor. The real concern for Southeast Pipe was finding a solution to repair a collapse in a location where excavation could not be done. The first priority was to repair the collapse and open the pipe up for water to flow through. After brainstorming, SPS construction managers found tunnel liner plates with CIPP (cured-in-place pipe) to be the best option. SPS proposed to install tunnel liner plates from CB3 going downstream until good pipe was found to tie into. Once the tunnel liner plate was installed, the remaining line could be inspected for further possible deformation.

Propex approved the plan. The cleaning and inspection crew proceeded with cleaning in other areas of the plant while the construction crew began installation of the tunnel liner plate. After 2 weeks of hand digging in mud, the tunnel liner plate was complete.

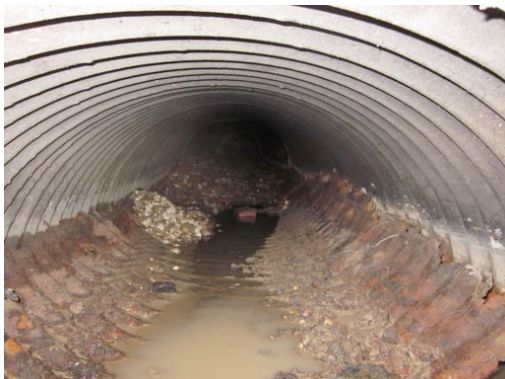
Partially Collapsed Lines Inside the Plant

The cleaning crew then focused on a 36" pipe and the remaining line segments inside the building. They cautiously cleaned the pipes and were able to verify what was feared. The next line segment was deteriorated to the extent of possible collapse.

CIPP was the only solution. Measurements were taken to verify pipe size and lengths. An order was placed with Daystar Composites (manufacturer of the liner) with the specific dimensions and lengths.

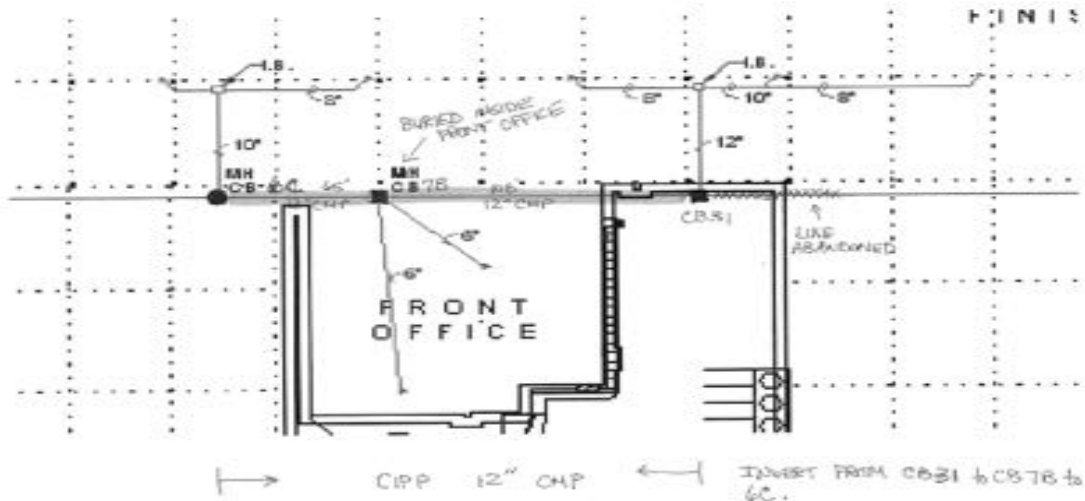
The next step was to line the remaining line segments inside the building. Again, careful measurements were taken and the liner was ordered. The first install was 2 - 12" corrugated metal pipe that had no bottom.

The line segment ran under the front office where excavation was not possible. The CCTV crew tried several times to inspect the line segments with the camera mounted on the transporter. Attempts continually failed because when the camera tractor would fall into holes in the pipe. There is no bottom to the pipe.

Southeast Pipe devised a sled, mounted the camera inside, stung cable through the line and pulled the sled through the line with a winch. This enabled the 2 line segments to be properly inspected. The CCTV crew was able to provide accurate measurements for the CIPP liner. The liner was successfully installed from the outside catch basin.

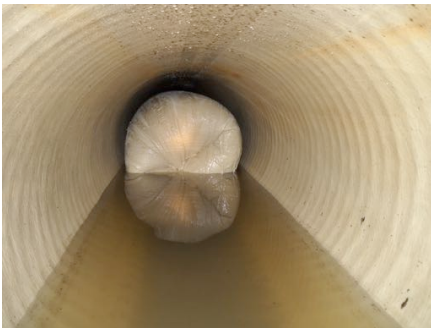
(Photo: 24" being installed thru 30" CIPP)

Careful measurements were taken and Daystar Composites manufactured the liners. The next upstream line was inverted from CB 1A. Dry liner inverted up to CB 3. Then the CIPP started and ended at CB 4. Once the line cured, the ends were cut. The next 3 lines had to be done the same way. Inverted from CB 1A.
