Stormwater System Repair

Project Name: Propex
Method Used: CIPP Lining with Tunnel Liner Plates
Original Pipe Material: Corrugated Metal Pipe

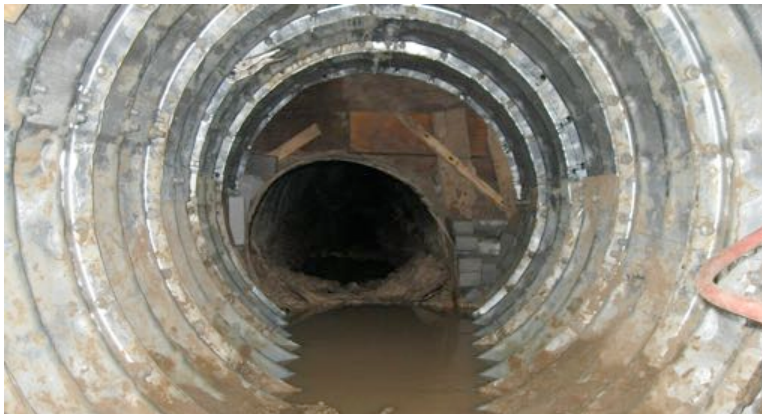
Along with the collapse, there was a 10' to 15' void underneath the floor. The real concern for Southeast Pipe was finding a solution to repair a collapse in a location where excavation could not be done. The first priority was to repair the collapse and open the pipe up for water to flow through. After brainstorming, SPS construction managers found tunnel liner plates with CIPP (cured-in-place pipe) to be the best option. SPS proposed to install tunnel liner plates from CB3 going downstream until good pipe was found to tie into. Once the tunnel liner plate was installed, the remaining line could be inspected for further possible deformation.

Propex approved the plan. The cleaning and inspection crew proceeded with cleaning in other areas of the plant while the construction crew began installation of the tunnel liner plate. After 2 weeks of hand digging in mud, the tunnel liner plate was complete.

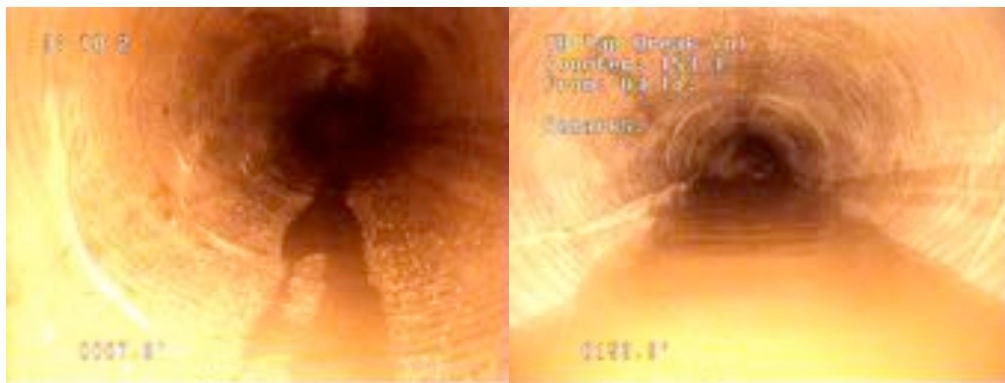
The inversion started at CB 1A. Dry bag was installed to the 107' mark and the CIPP liner started from there to CB 3. The liner went through 2 catch basins to get to its destination at CB 3. The liner was cured and the catch basins and the ends were cut out.

The liner looked great, the collapse was repaired and the possible collapse was eliminated. The void was then pumped with cellular grout to fill in the voided area around the pipe and to the concrete floor above the repaired corrugated metal pipe storm drain.

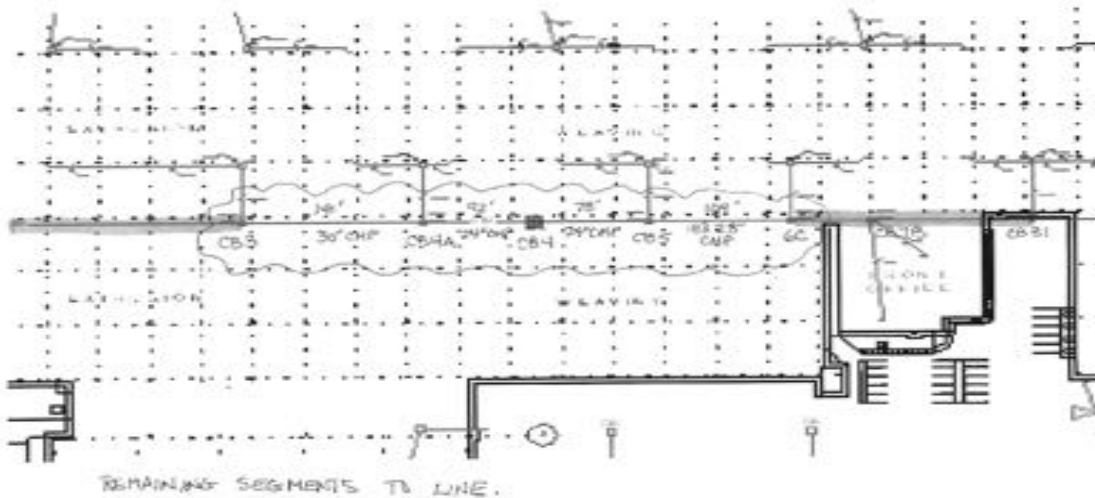
The line segment ran under the front office where excavation was not possible. The CCTV crew tried several times to inspect the line segments with the camera mounted on the transporter. Attempts continually failed because when the camera tractor would fall into holes in the pipe. There is no bottom to the pipe.

Southeast Pipe devised a sled, mounted the camera inside, stung cable through the line and pulled the sled through the line with a winch. This enabled the 2 line segments to be properly inspected. The CCTV crew was able to provide accurate measurements for the CIPP liner. The liner was successfully installed from the outside catch basin.
